## Symptoms:

When the CC-SG Hardware Appliance (shipped from the factory in early 2017) with firmware releases 6.2.0 or earlier is upgraded to newer firmware releases, users may experience an error message **“Failed to construct component instance”** when accessing the nodes/targets. In rare cases, CC-SG may experience boot failure after the upgrade.

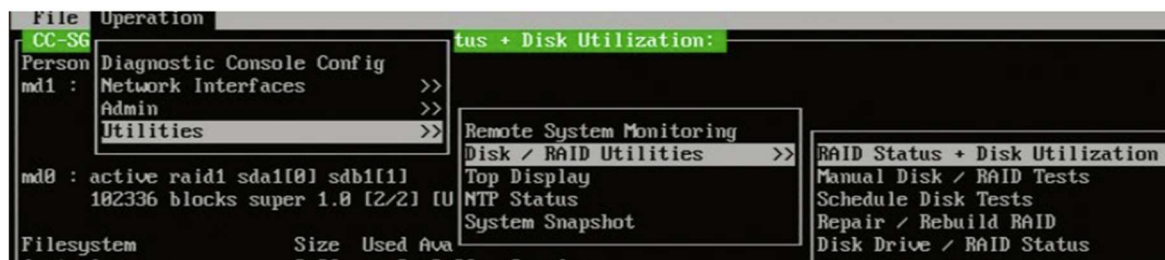
To check the /boot partition utilization, login to CC-SG on the [admin diagnostic console](#) and navigate to [Operation > Utilities > Disk / RAID Utilization > RAID Status + Disk Utilization](#)

If the boot partition is above 50% utilization, please [contact the technical support team](#) to obtain a patch to free up the space for the boot partition before applying the firmware upgrade.
